TECHNICAL REPORT H-77-22

BREAKWATER STABILITY STUDY IMPERIAL BEACH, CALIFORNIA

Hydraulic Model Investigation

Prepared for U. S. Army Engineer District, Los Angeles
Los Angeles, California 90053

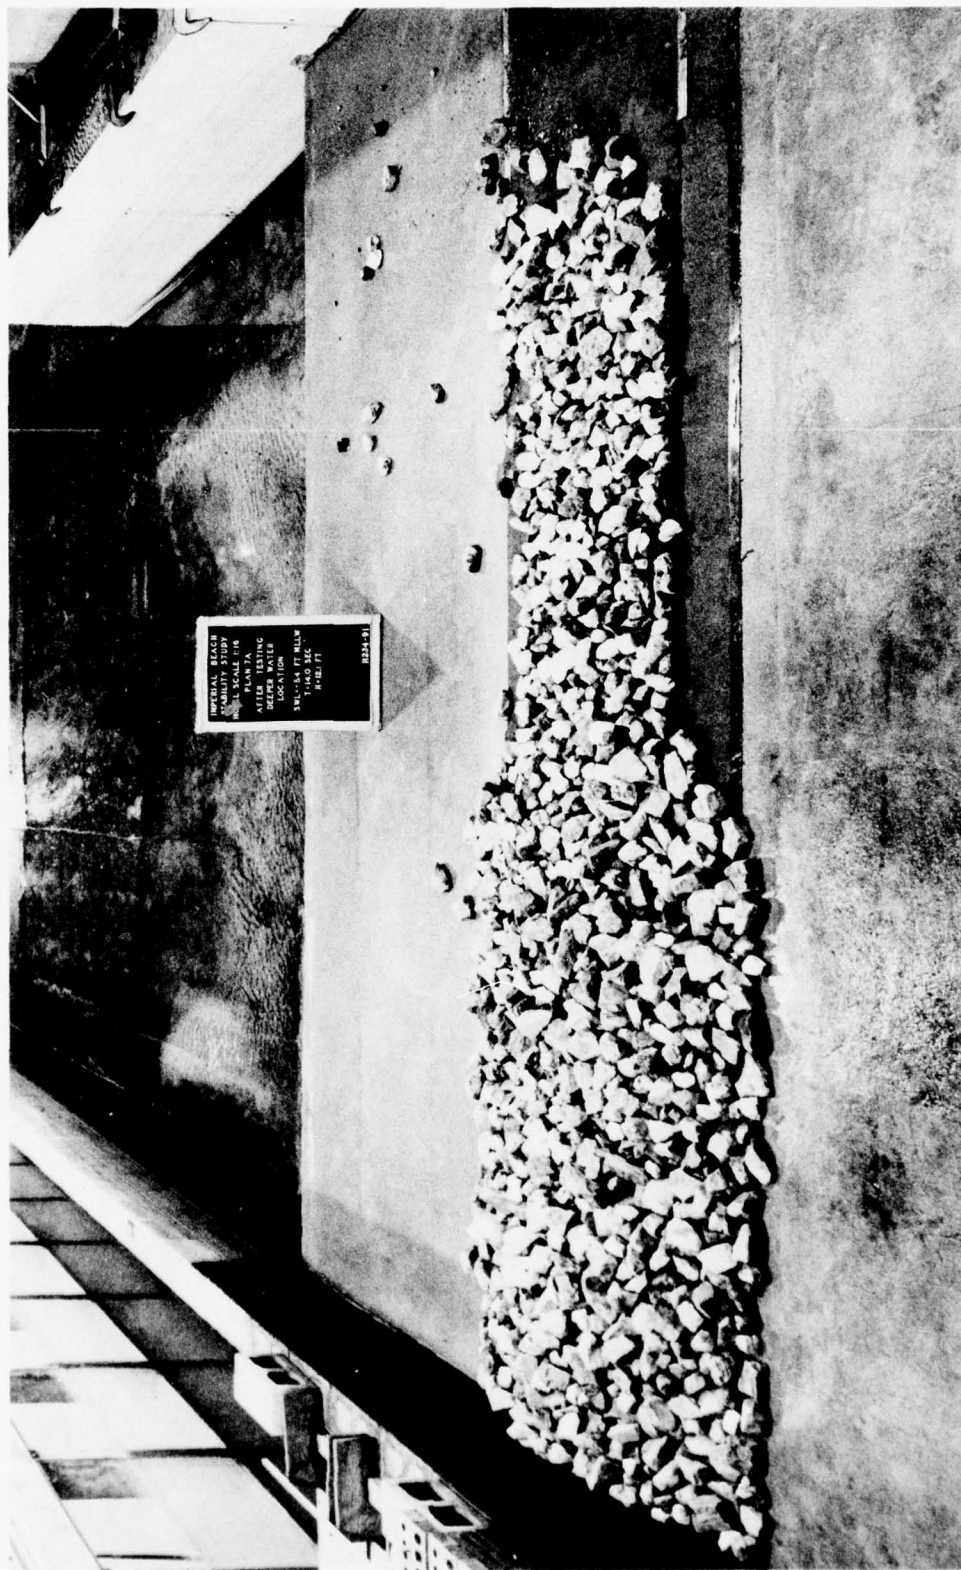
Photo 31. Sea-side view of Plan 7A in the deeper water location after 2.0 hr on the low sill and 4.0 hr on the high sill of 14.0-sec, 12.1-ft waves at an swl of +5.4 ft mllw

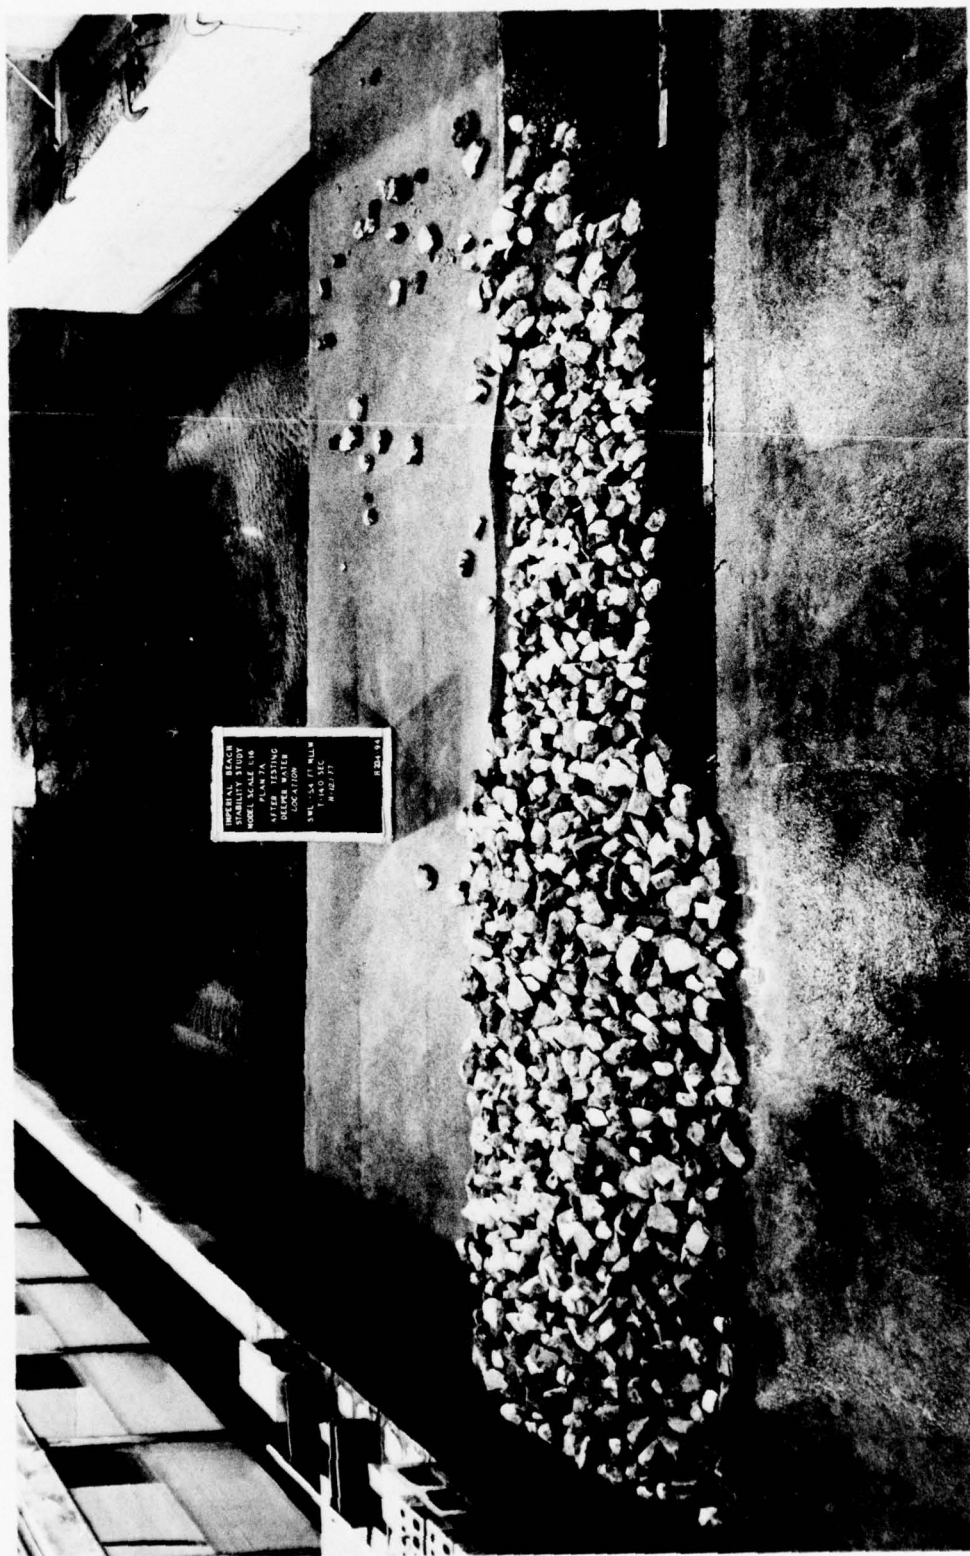
Photo 32. Sea-side view of Plan 7A in the desper water location after 4.0 hr on the low sill and 6.0 hr on the high sill of 14.0-sec, 12.1-ft waves at an swl of +5.4 ft mllw

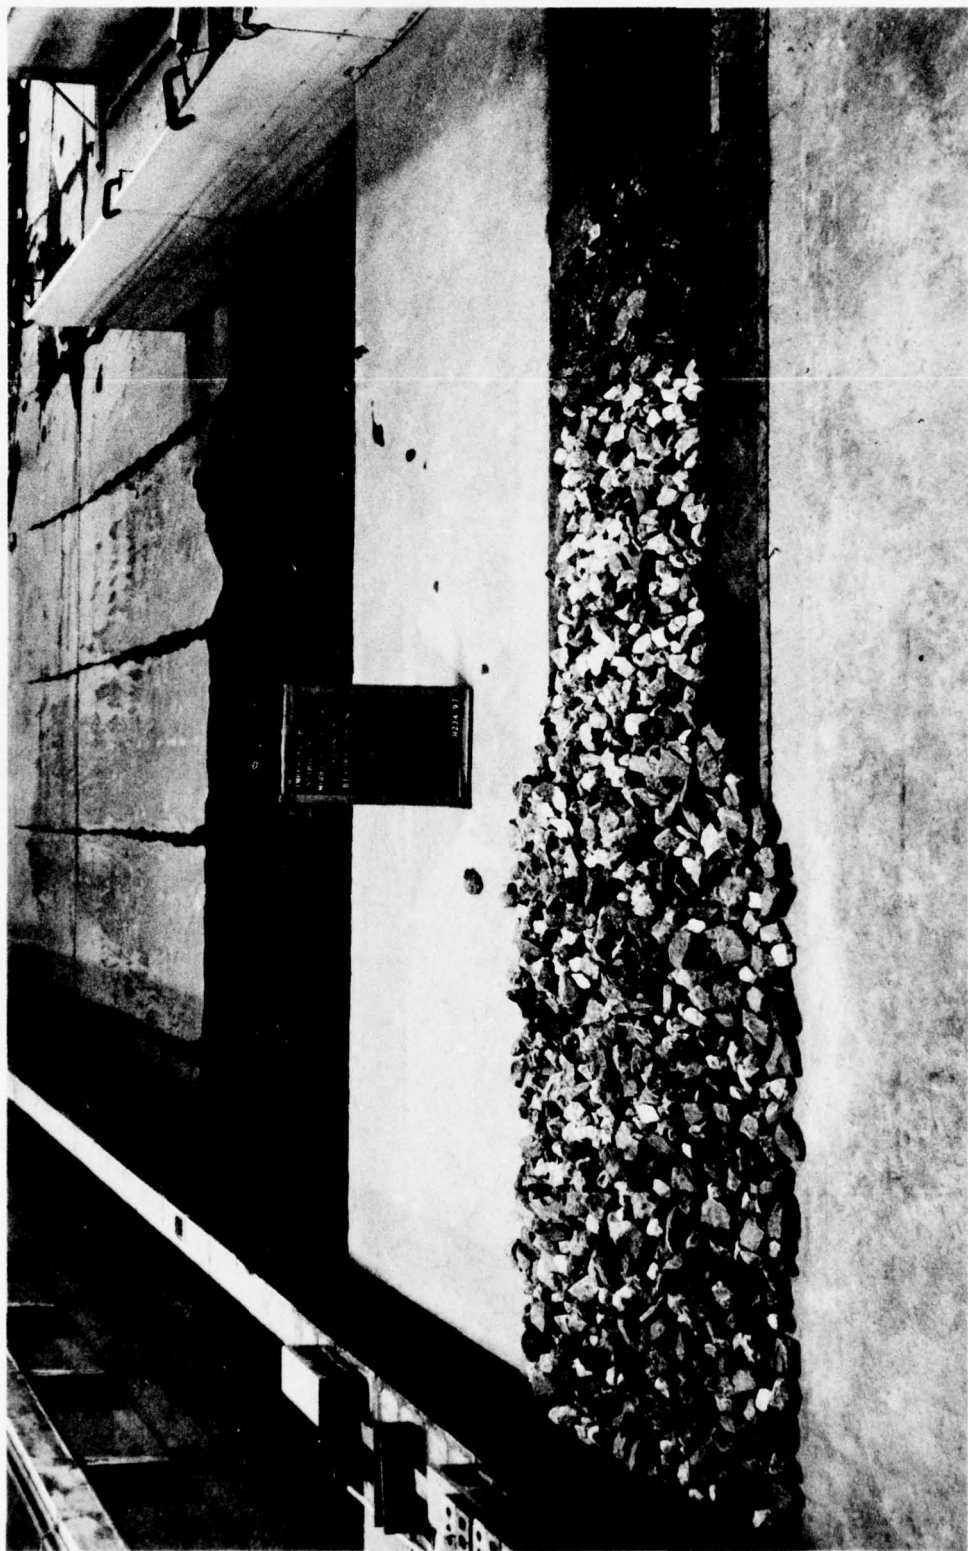
Photo 33. Sea-side view of Plan 7B before wave attack

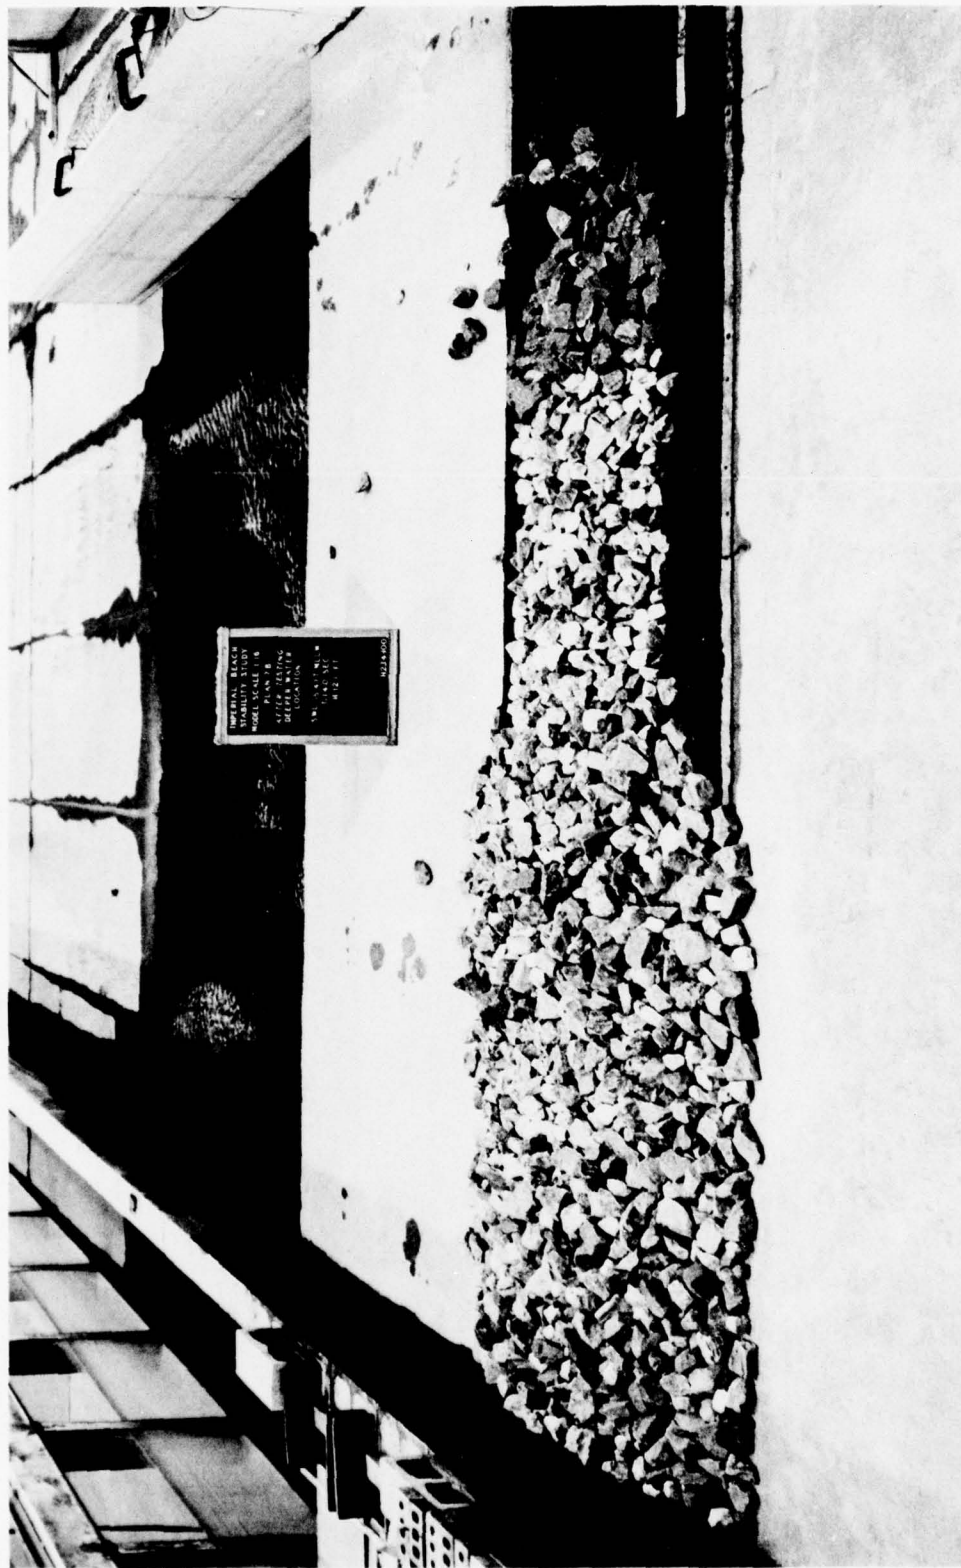
Photo 34. Sea-side view of Plan 7B in the deeper water location after 2.0 hr on low-sill head section and 15 ft of adjacent trunk, 6.0 hr on remainder of low sill, and 8.0 hr on high sill of 14.0-sec, 12.1-ft waves at an swl of +5.4 ft mllw

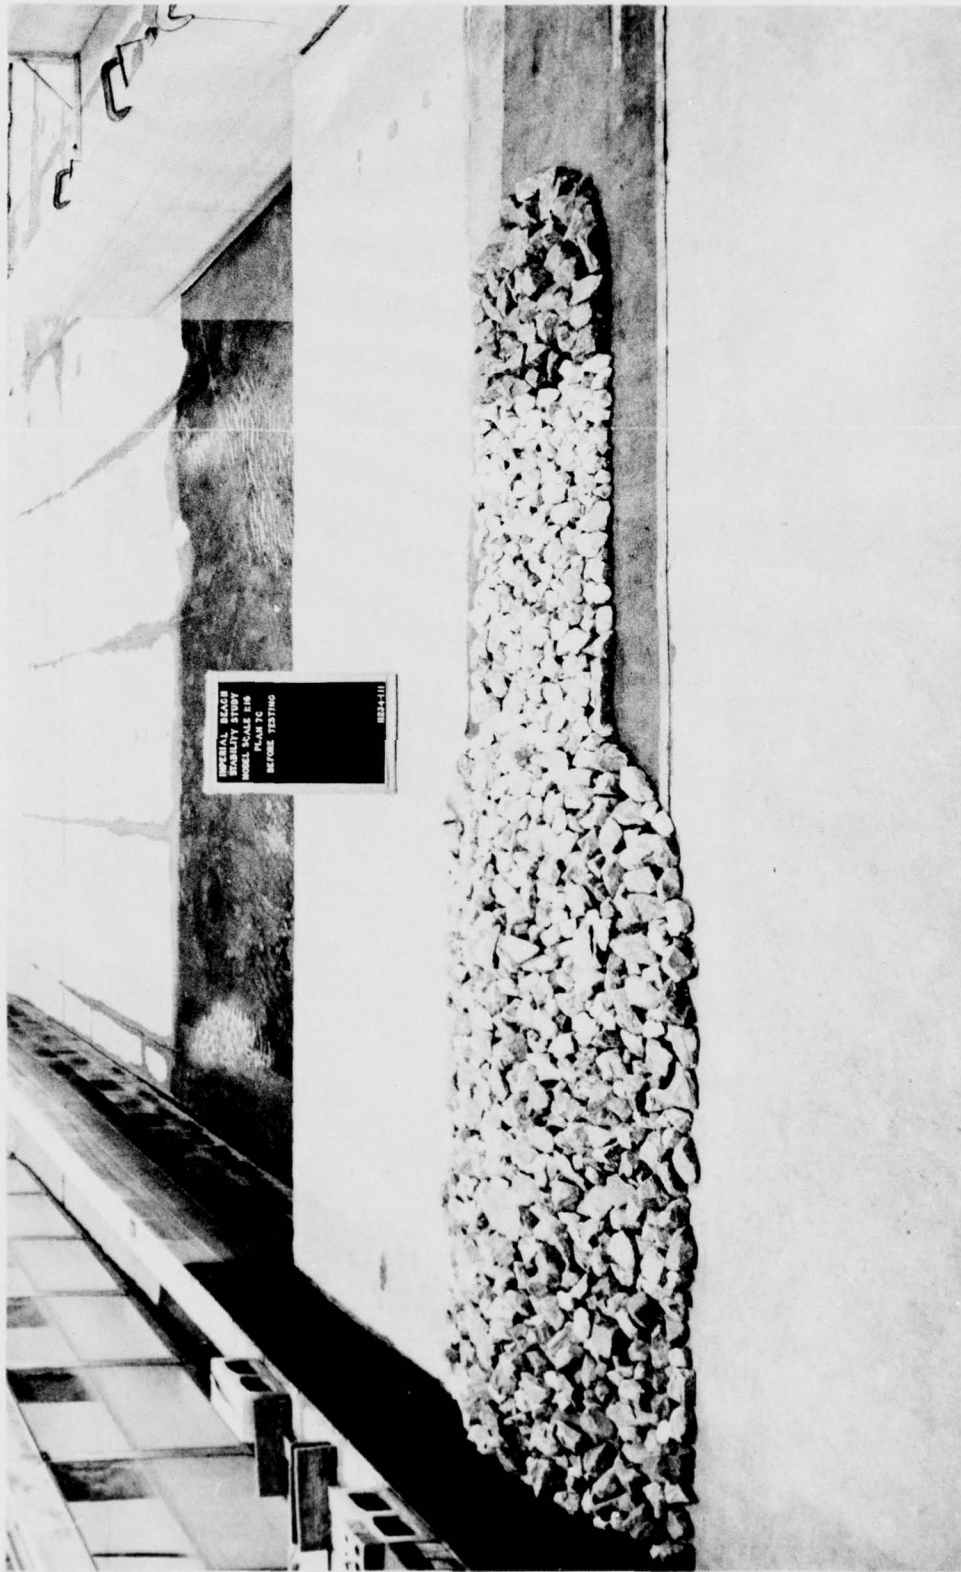
Photo 35. Sea-side view of Plan 7C before wave attack

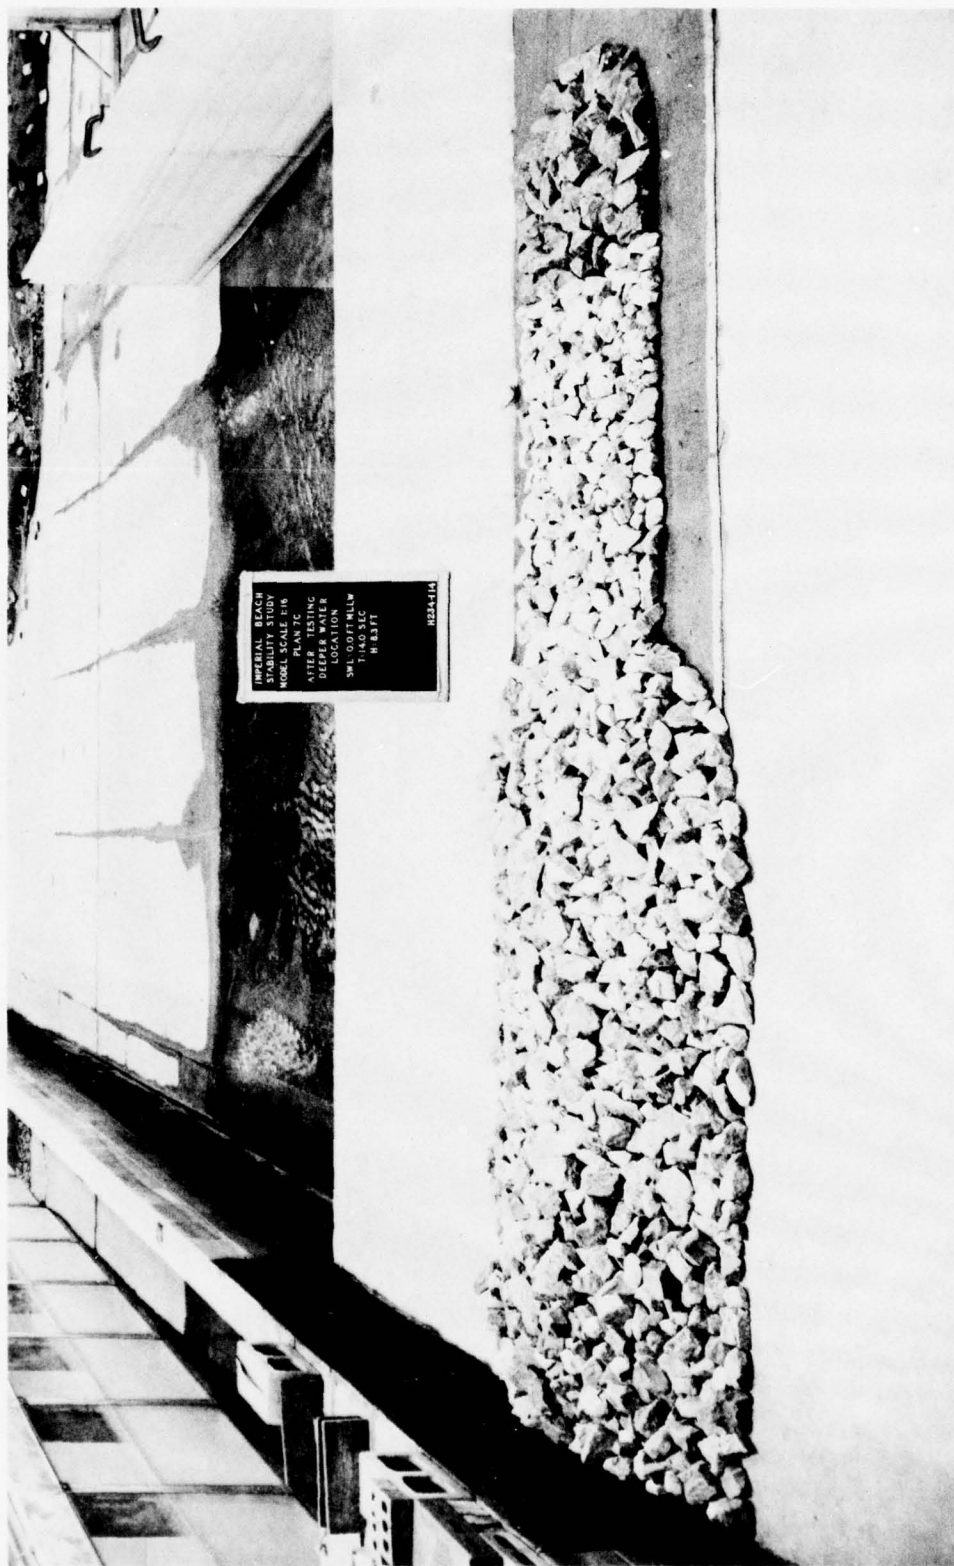
Photo 36. Sea-side view of Plan 7C in the deeper water location after 1.0 hr of 14.0-sec, 8.3-ft waves at an swl of 0.0 ft mllw

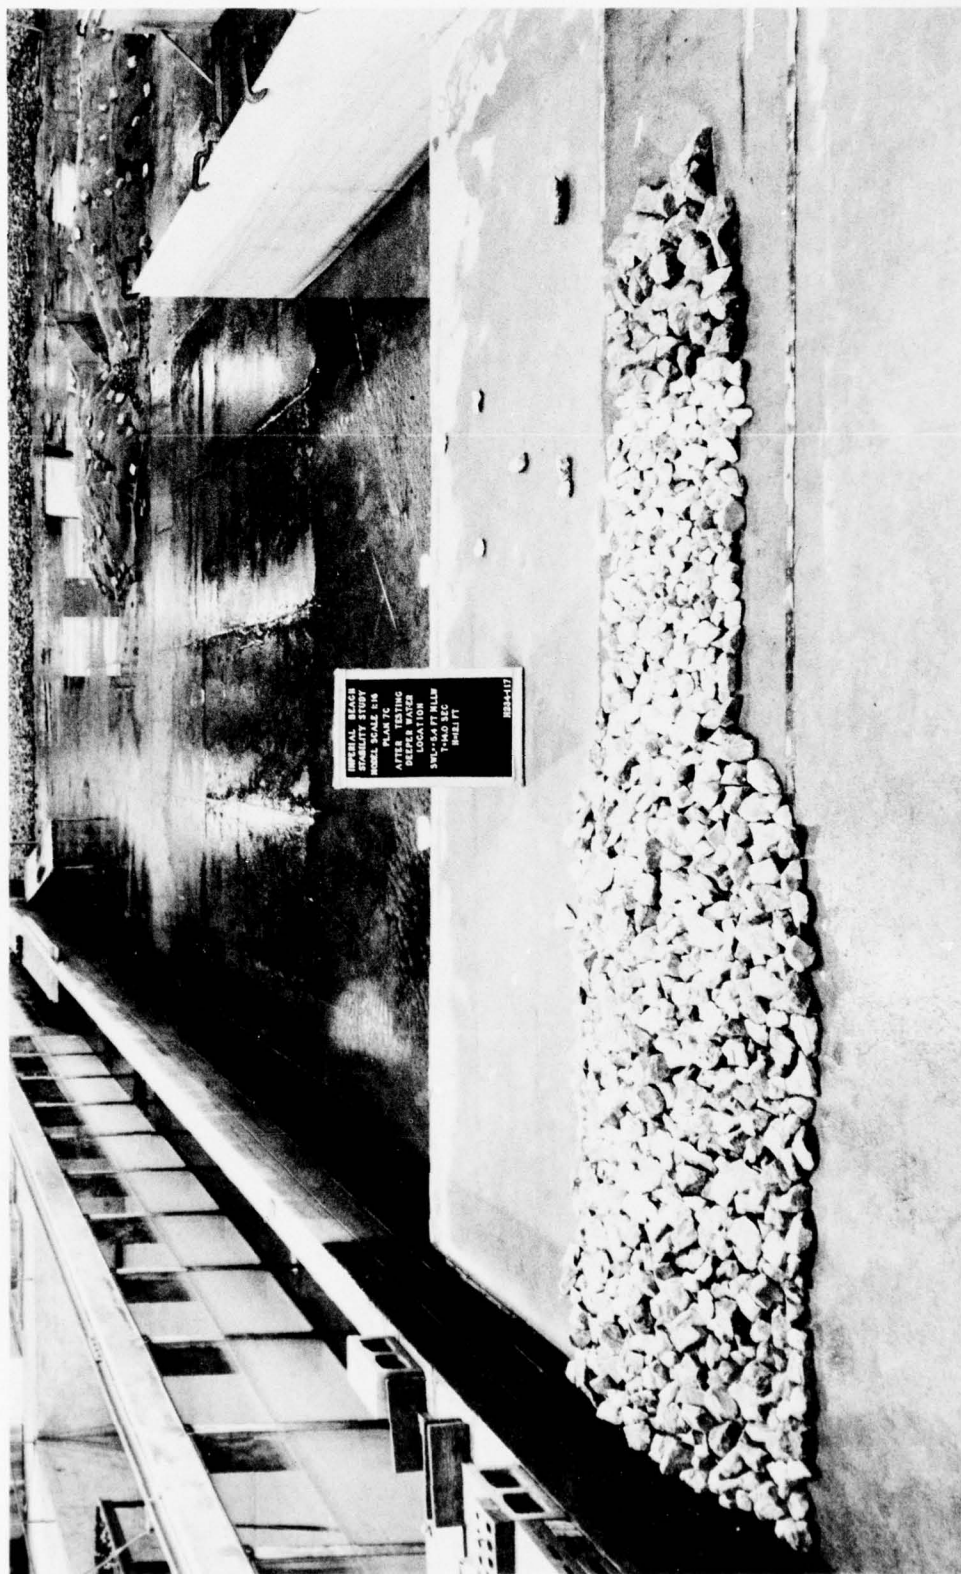
Photo 37. Sea-side view of Plan 7C in the deeper water location after 2.0 hr of 14.0-sec, 12.1-ft waves at an swl of +5.4 ft mllw

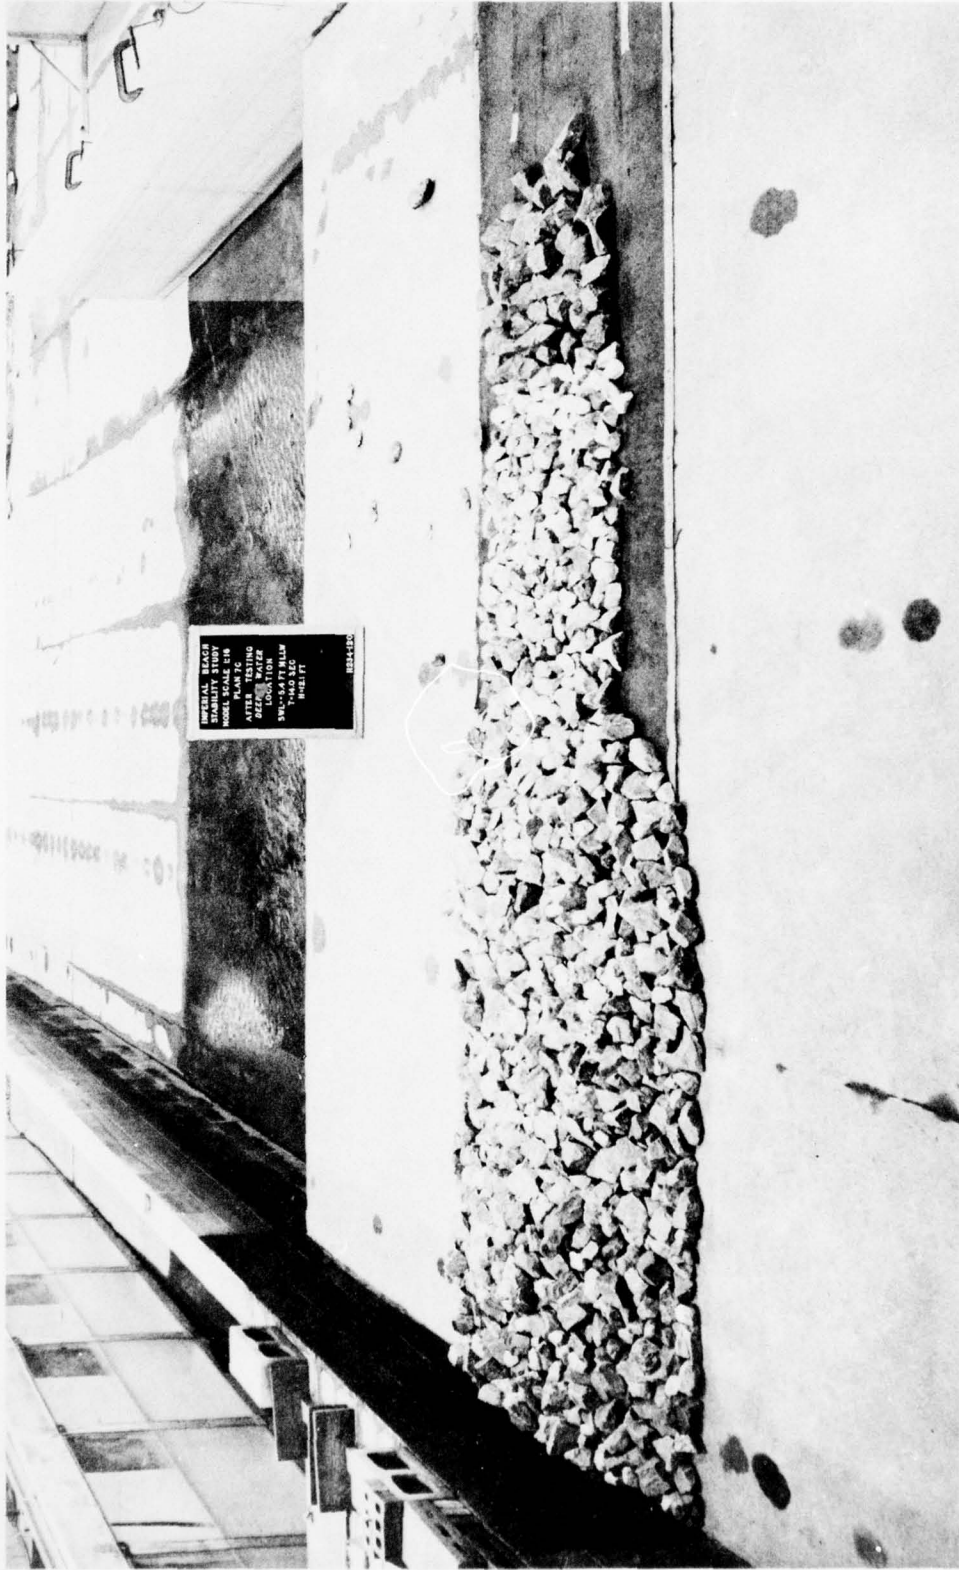
Photo 38. Sea-side view of Plan 7C in the deeper water location after 4.0 hr of 14.0-sec, 12.1-ft waves at an swl of +5.4 ft mllw

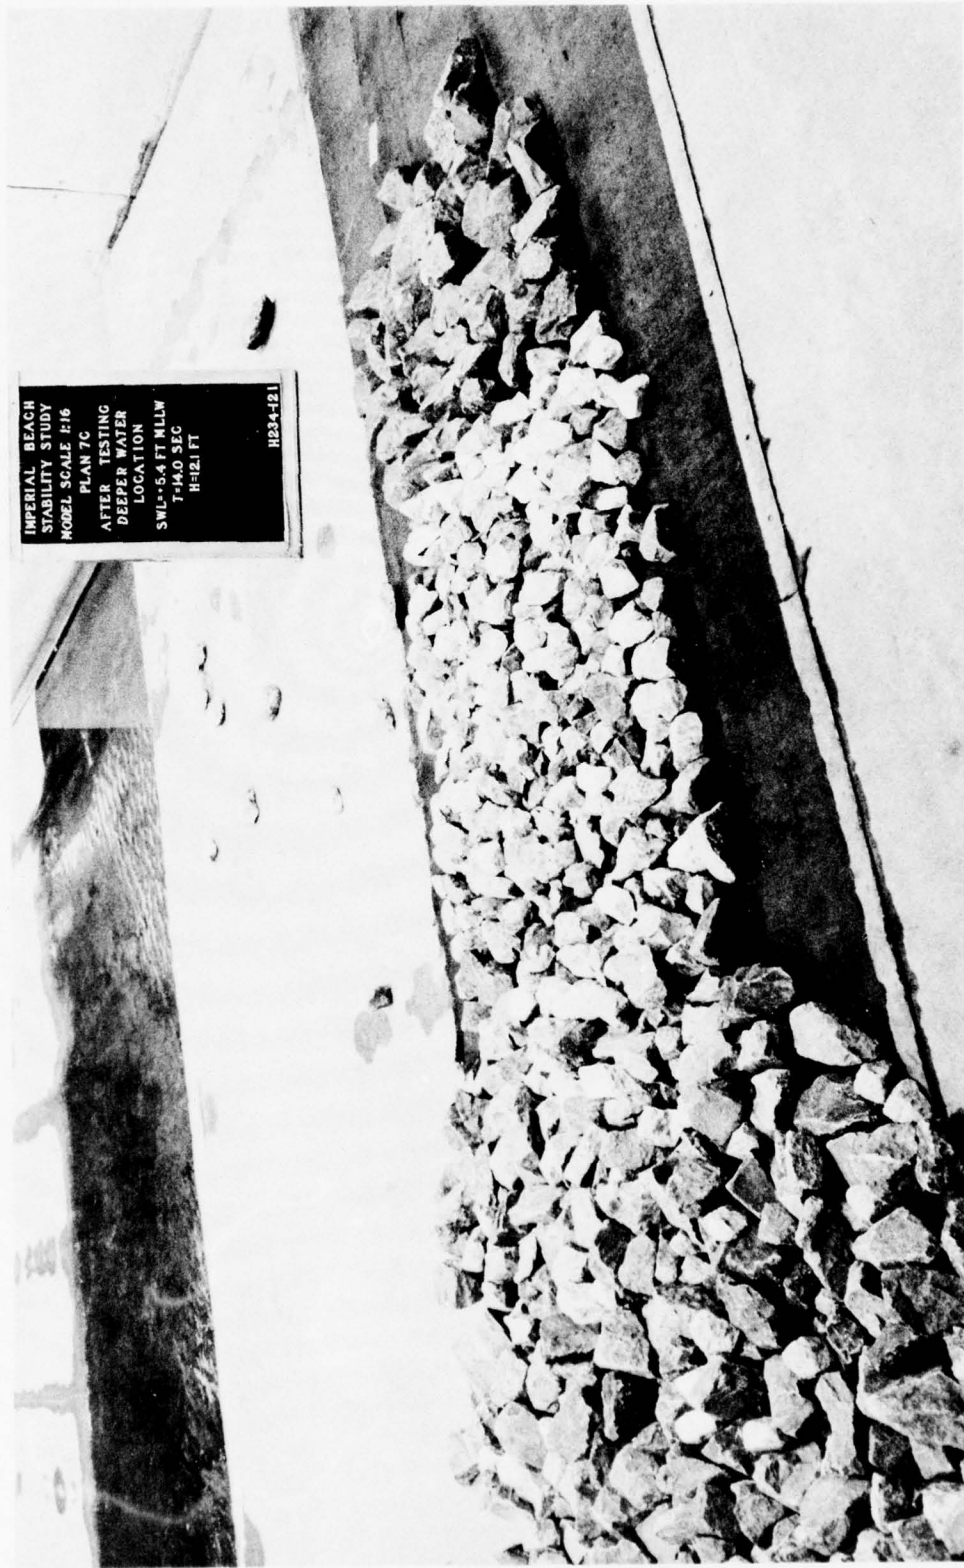
Photo 39. Sea-side view of low-sill section of Plan 7C in the deeper water location after 4.0 hr of 14.0-sec, 12.1-ft waves at an swl of +5.4 ft mllw

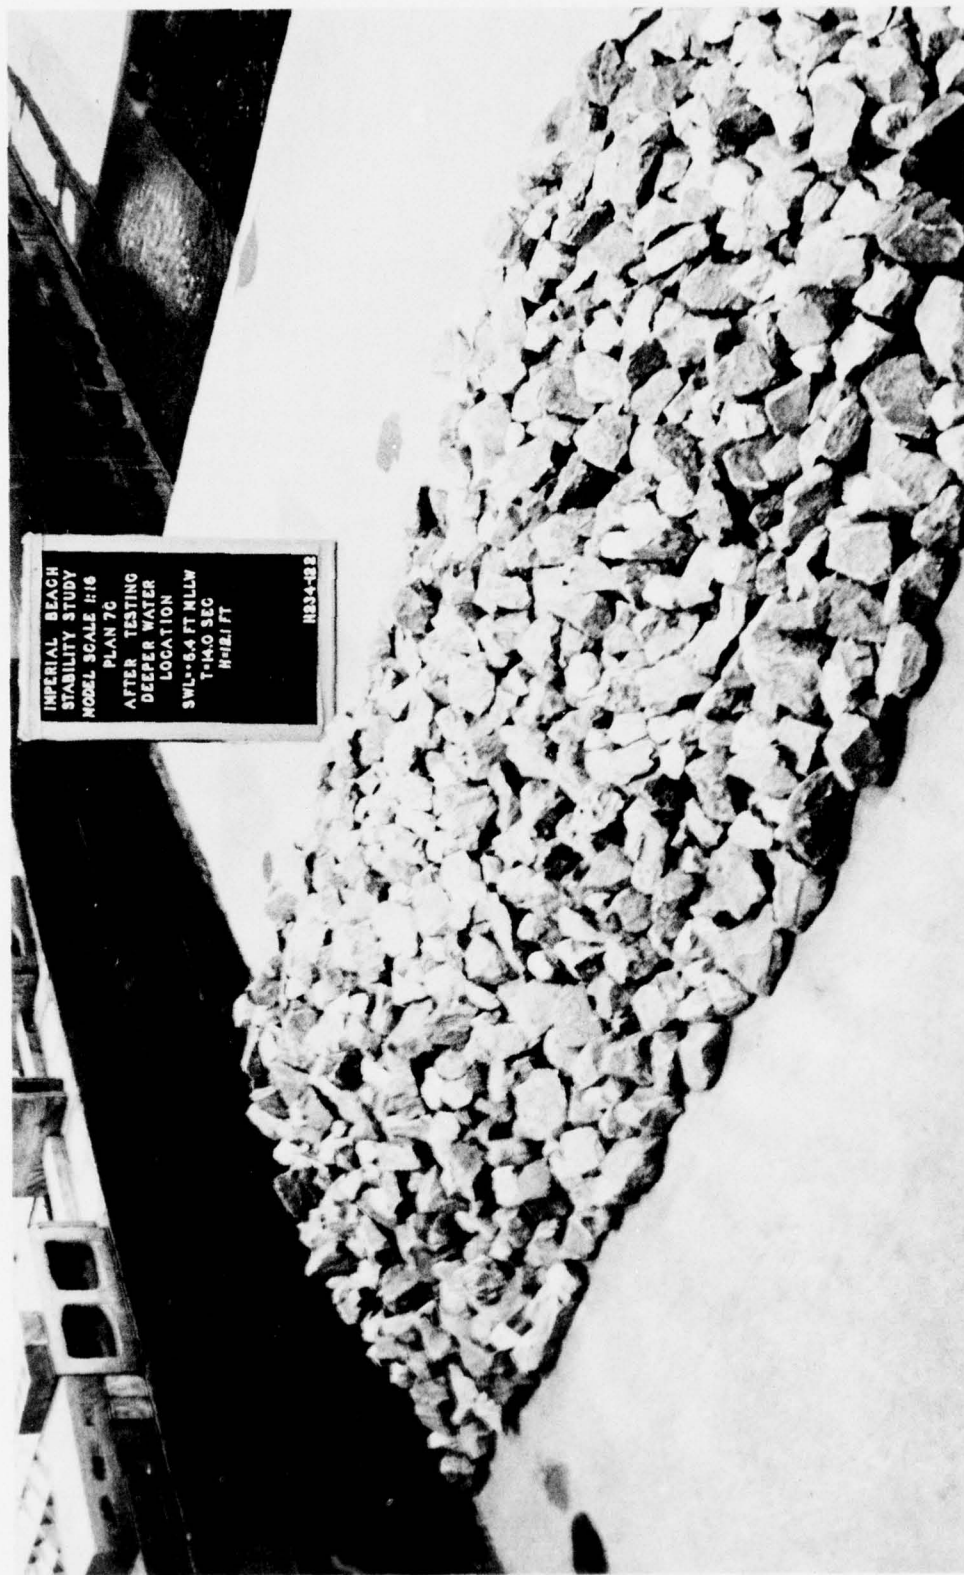
Photo 40. Sea-side view of high-sill section of Plan 7C in the deeper water location after 4.0 hr of 14.0-sec, 12.1-ft waves at an swl of +5.4 ft mllw

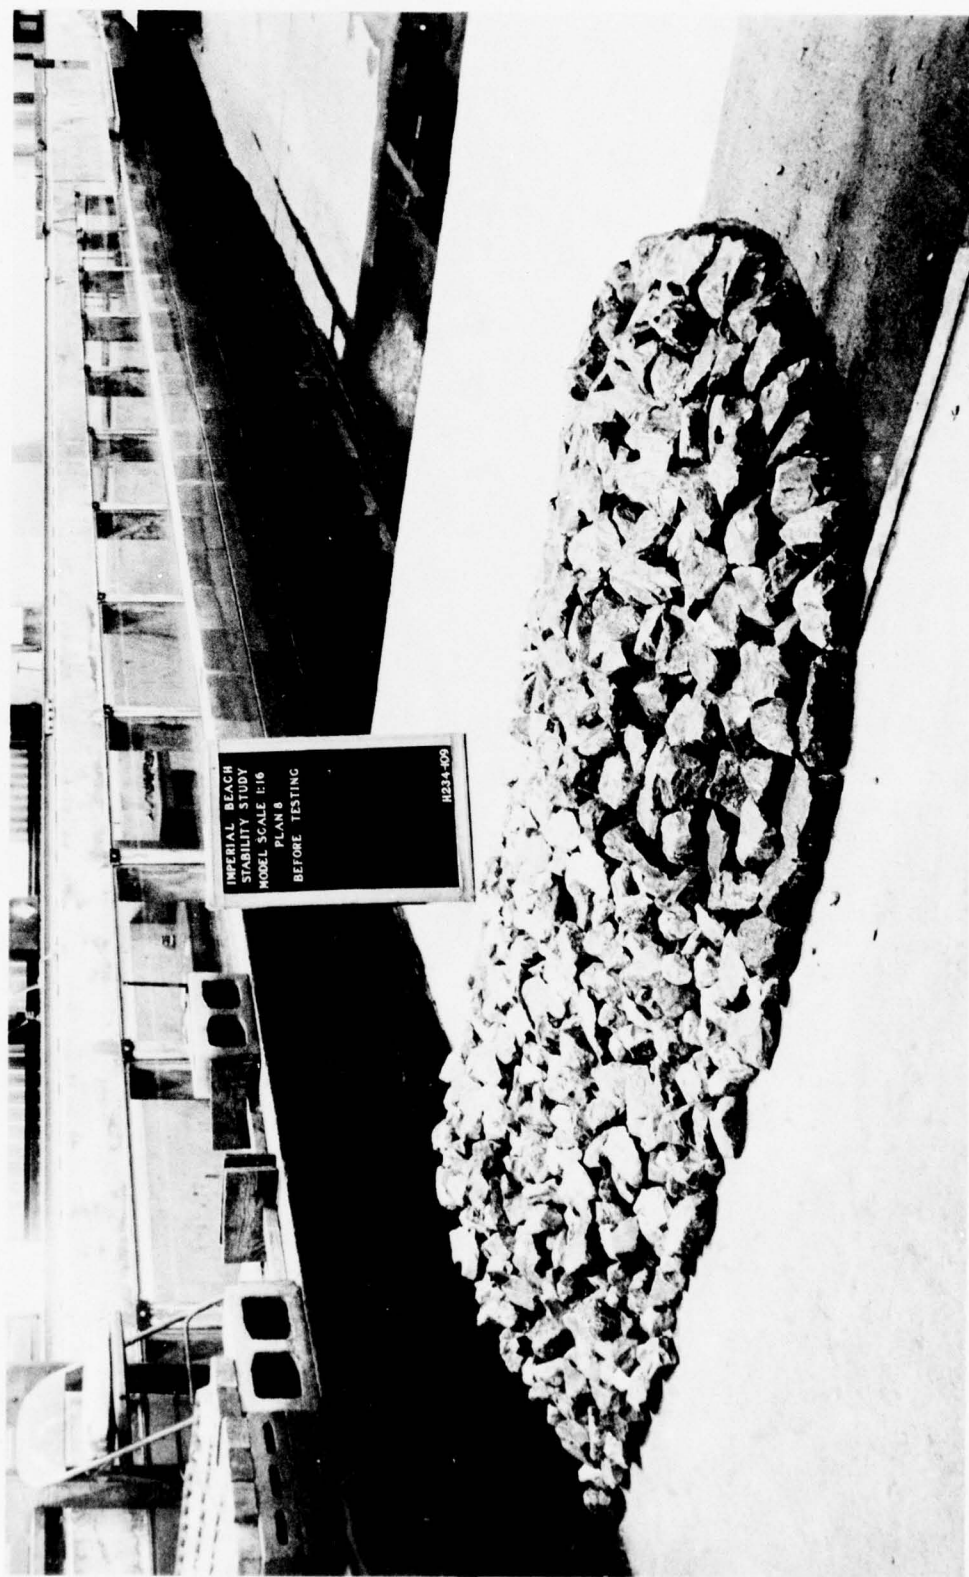
Photo 41. Sea-side view of Plan 8 before wave attack

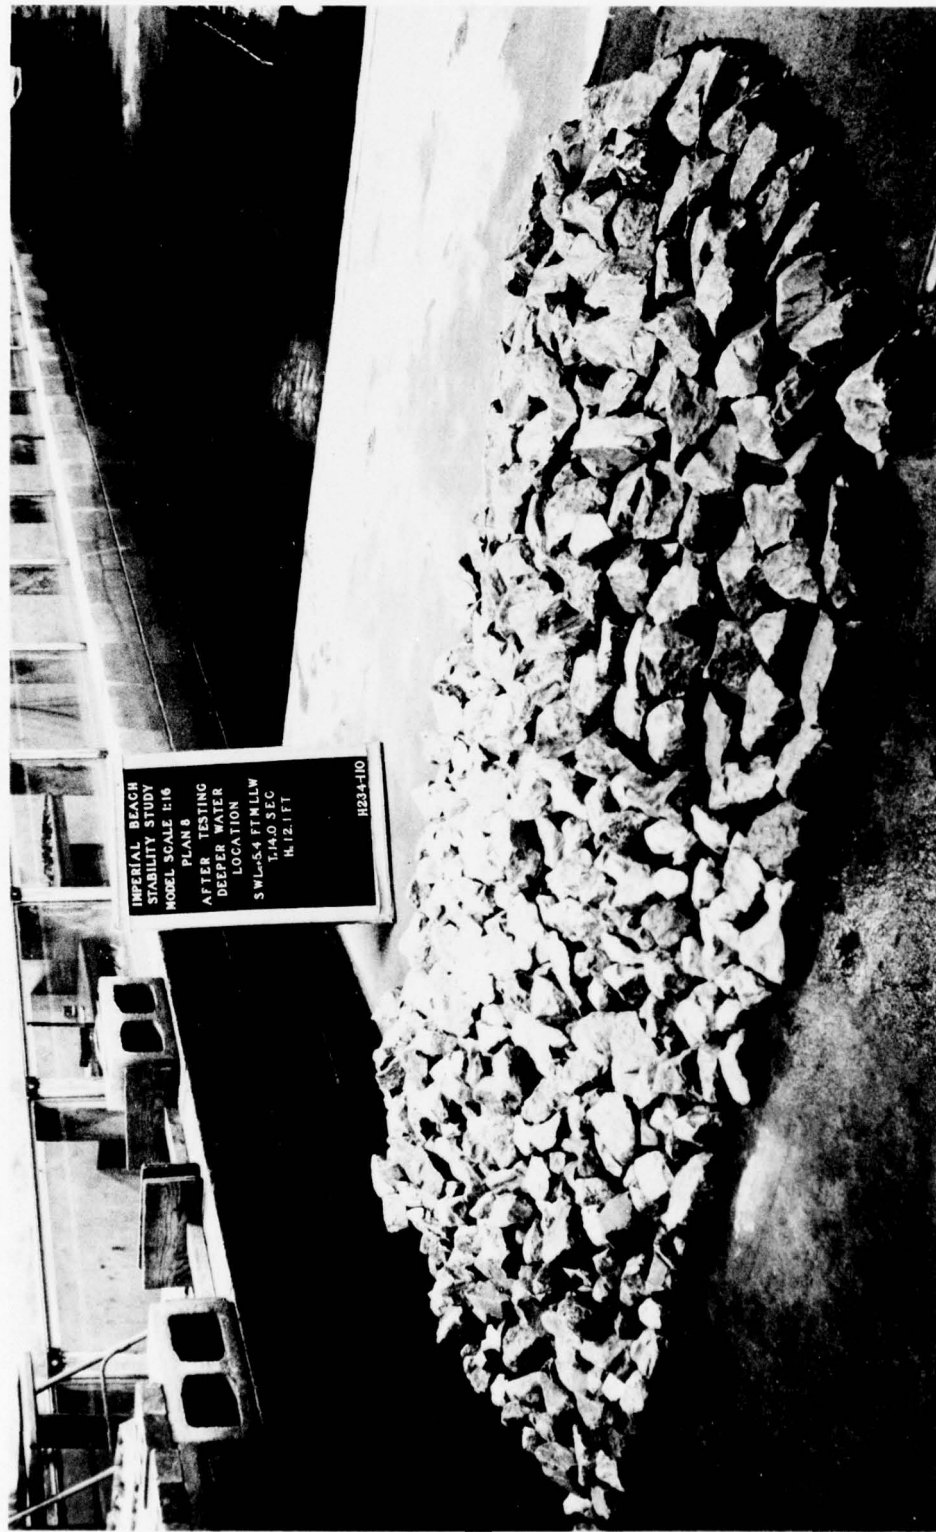
Photo 42. Sea-side view of Plan 8 in the deeper water location after 2.0 hr of 14.0-sec, 12.1-ft waves at an swl of +5.4 ft mllw

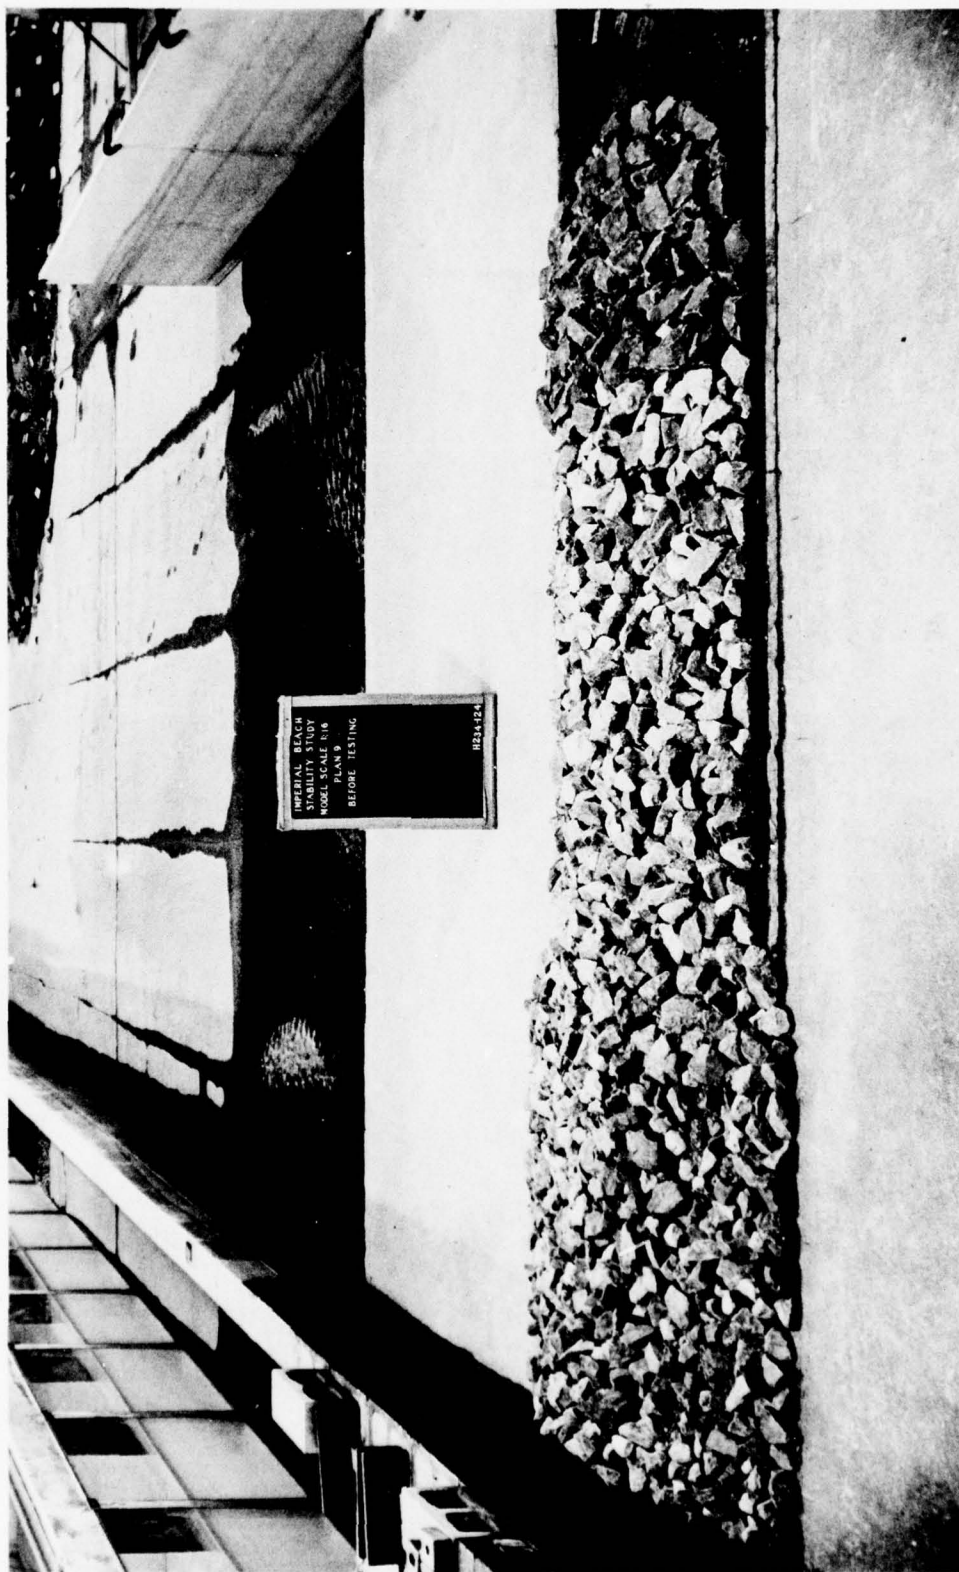
Photo 43. Sea-side view of Plan 9 before wave attack

23. Plan 9 (Plate 12 and Photo 43) was run in an effort to steepen the breakwater slopes and thus reduce construction costs by

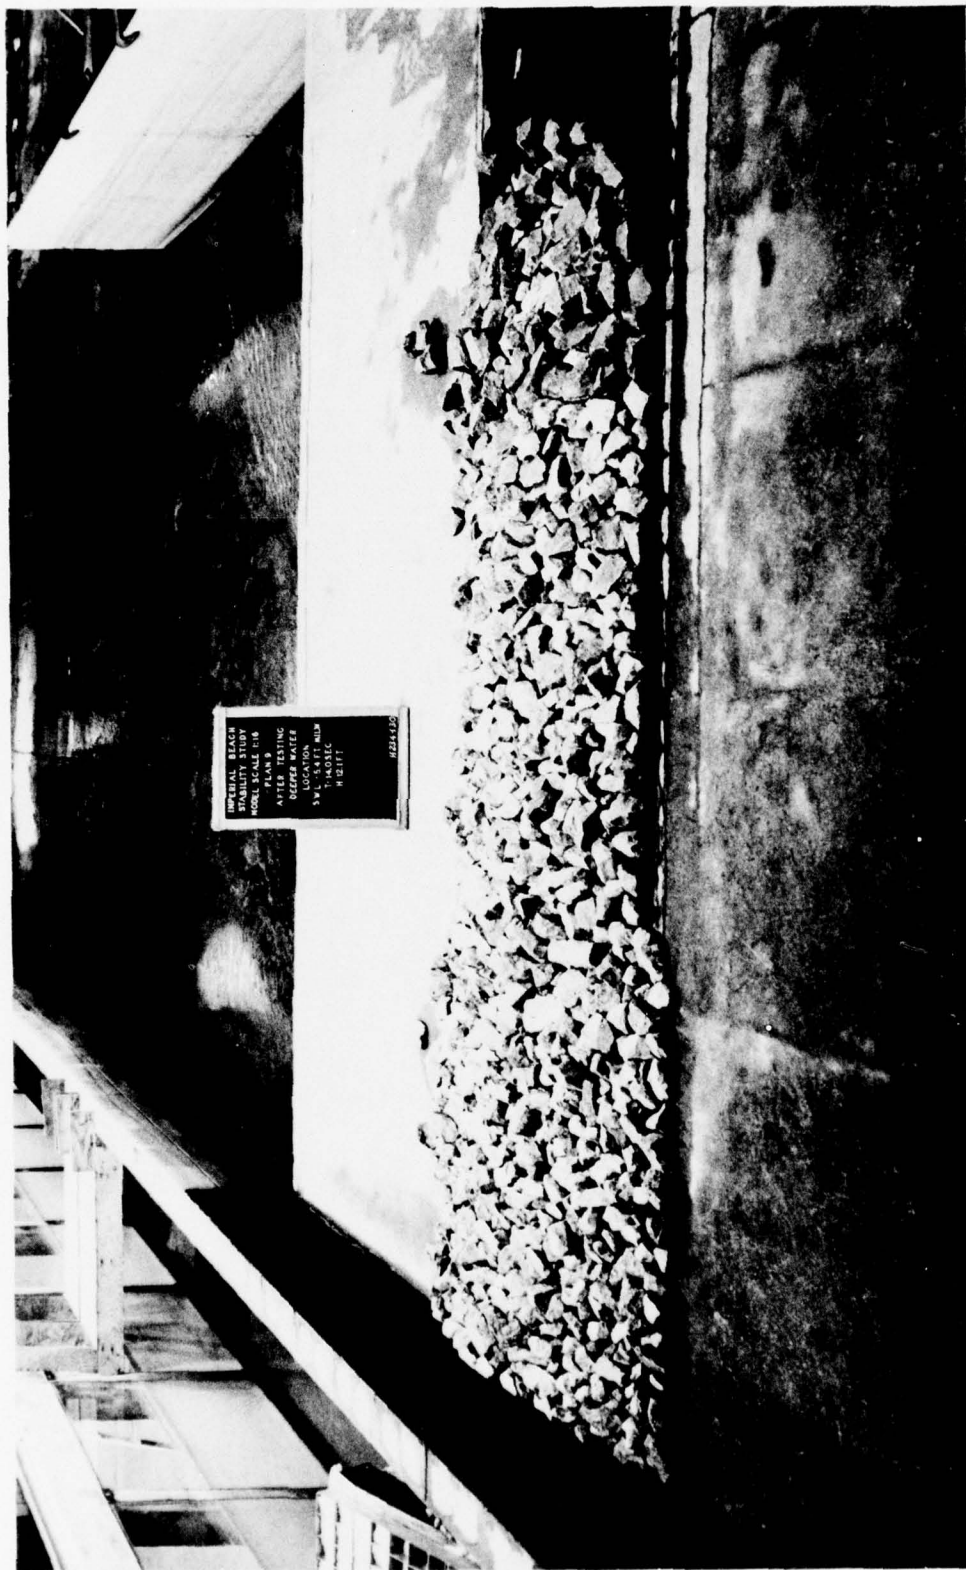
Photo 44. Sea-side view of Plan 9 in the deeper water location after 4.0 hr of 14.0-sec, 12.1-ft waves at an swl of +5.4 ft mllw

minimizing the amount of construction material. Plan 9, in the deeper water location, consisted of two high-sill trunk sections with 1V-on-3H and 1V-on-2H slopes, respectively, and a high-sill head with 1V-on-2H slopes; 5.0-ton graded armor stone was used on both trunk sections. Except for the steeper 1V-on-2H slopes, the Plan 9 head section was identical with the Plan 8 head section described in paragraph 22. A crown elevation of 0.0 ft mllw was used for the entire breakwater test section. After 4.0 hr of exposure to 14.0-sec, 12.1-ft waves at an swl of +5.4 ft mllw, very minor damage could be seen on the 1V-on-3H slope trunk section, minor damage on the 1V-on-2H slope trunk section, and moderate damage to the 7.0-ton capstone on the head section of the breakwater (Photo 44).
